McClure Home Inspections  
1914 N. 22nd Street  
Grand Junction, Colorado 81501

# Steve McClure Home Inspections

Others Present : Buyer Property Occupied : Vacant  
Estimated year built : 1950 Entrance Faces : Northeast  
Inspection Date :  
Start Time : 10:30 AM End Time : 4:00 PM  
Electric On : Yes  
Gas/Oil On : Yes  
Water On : No  
Temperature : 80  
Weather : Sunny Soil Conditions : dry  
Space Below Grade : Crawl Space  
Building Type : Single family Garage : Detached

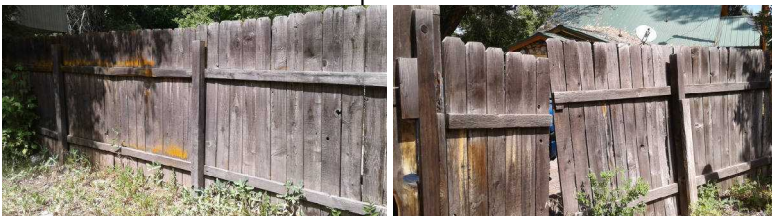
8. Fences: Wood, Picket - Needs replacement, Wood rot or pest damage, A qualified contractor is recommended to evaluate and estimate repairs

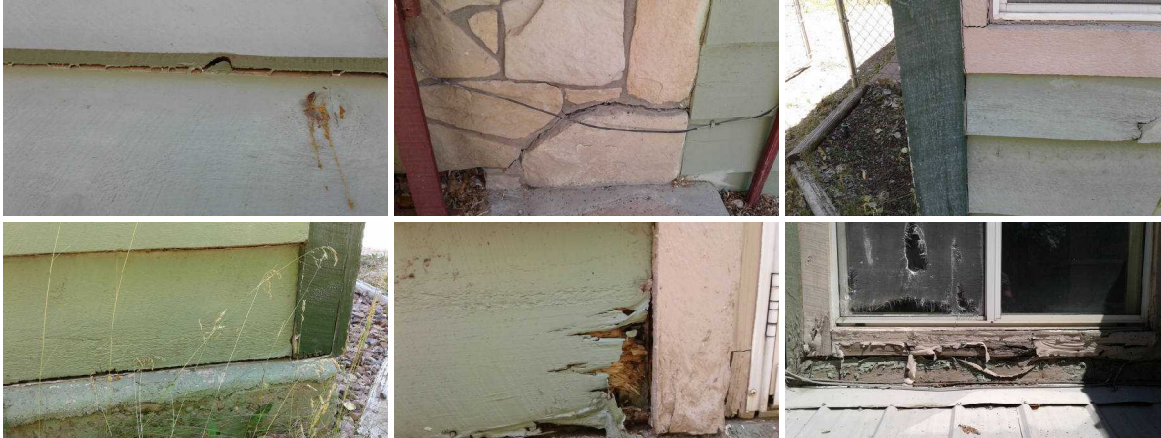
1. Type: Wood - Paint peeling, Rot noted, Stress cracks

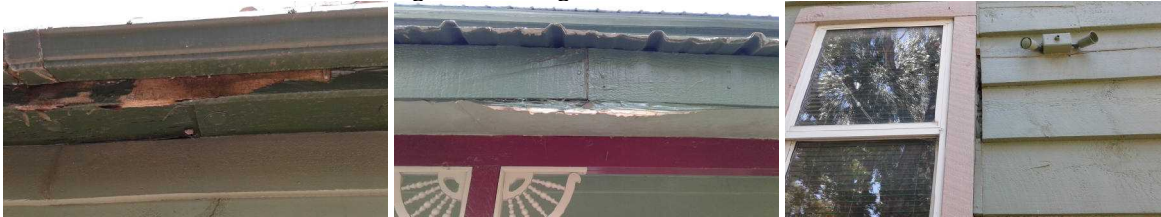
2. Trim: Wood - Wood rot, Damaged, Missing, Loose

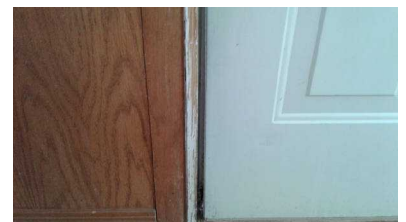
5. Patio Door: Metal sliding, Metal entry door - Screen door off track, Rollers need to be replaced. A qualified contractor is recommended to evaluate and estimate repairs

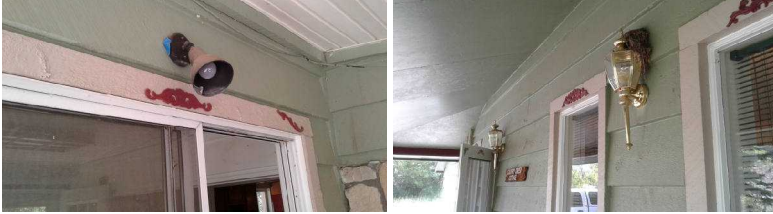
8. Exterior Lighting: Surface mounted lamps front and rear - Bulbs burned out at time of inspection.

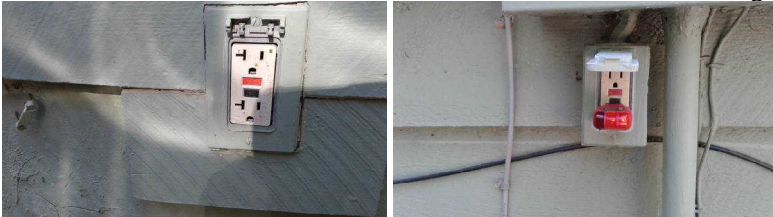
9. Exterior Electric Outlets: 110 VAC GFCI - Loose or missing moisture cover. GFCI test fail by electrical box.

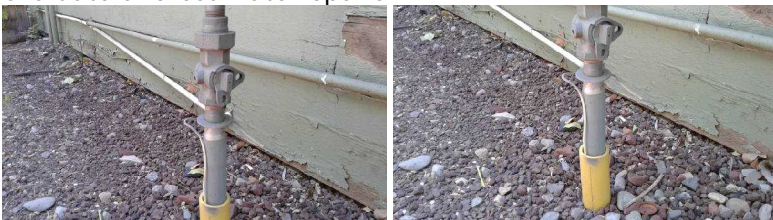
12. Main Gas Valve: Located at gas meter - Ground wire not attached. A licensed plumber is recommended to evaluate and estimate repairs.

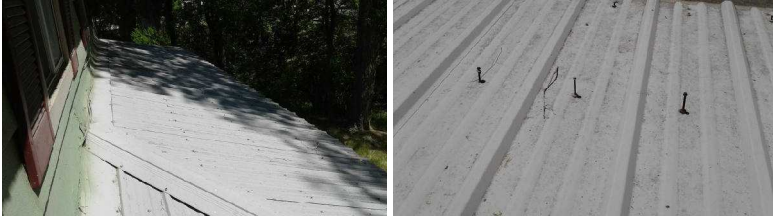
1. Method of Inspection: On roof, Ladder at eaves
2. Material: Tin - Metal fastened improperly, A qualified roofing contractor is recommended to evaluate and estimate repairs

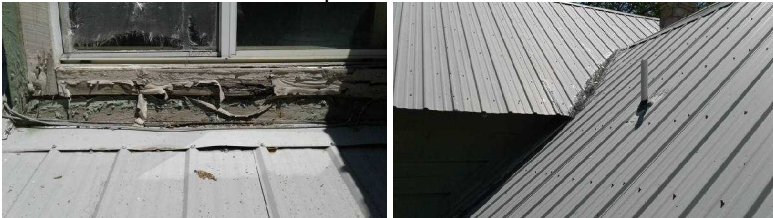
3. Flashing: Aluminum, Galvanized - Prone to possible leaks, A qualified roofing contractor is recommended to evaluate and estimate repairs

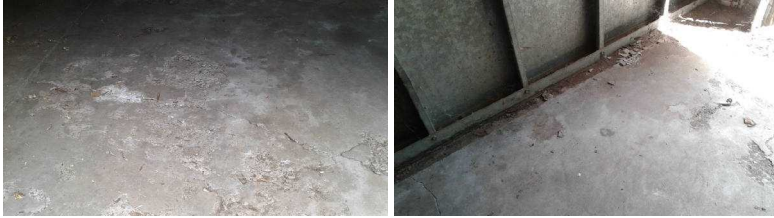
8. Floor/Foundation: Poured concrete, Poured slab - Minor floor cracks noted-seal cracks, Spalled foundation corners

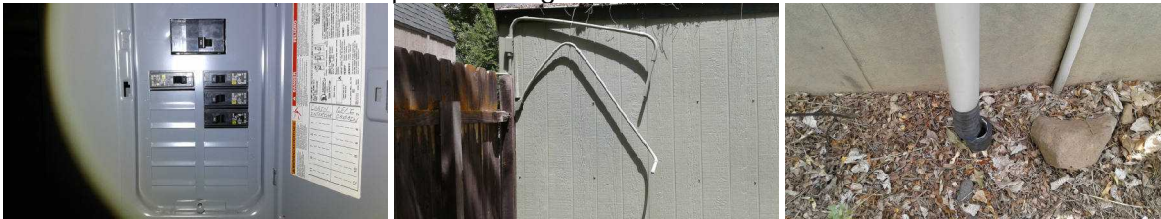
9. Electrical: 110 VAC GFCI - Exposed wiring on exterior.

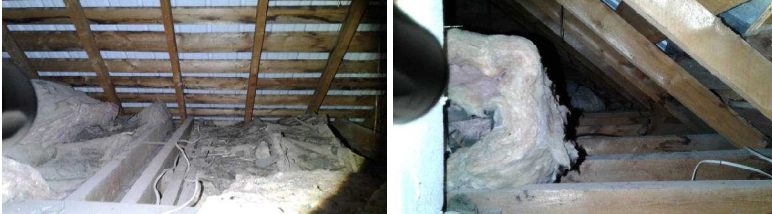
4. Insulation: Batts, Fiberglass - Insulation has been damaged by moisture. Insufficient insulation present, No insulation present, Recommend additional insulation be installed, A qualified contractor is recommended to evaluate and estimate repairs, Insulation batts have fallen out of position-properly reinstall.

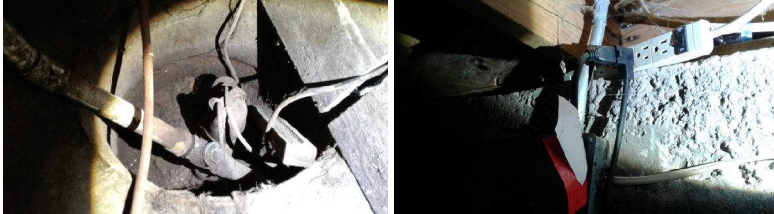
15. Main Crawl Space Sump Pump: Submerged - Inoperative at time of inspection, Sump pump not connected to dedicated circuit

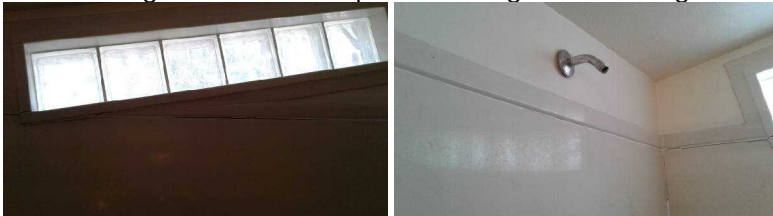
- 19. Windows: Aluminum slider
- 20. Electrical: 110 VAC GFCI
- 21. Counter/Cabinet: Wood, Composite and wood
- 22. Sink/Basin: Molded dual bowl
- 23. Faucets/Traps: Delta fixtures with a PVC trap
- 24. Shower/Surround: Porcelain pan and ceramic tile surround, Porcelain pan and fiberglass surround - Replace old caulking at the shower pan, Loose grout. missing shower head.

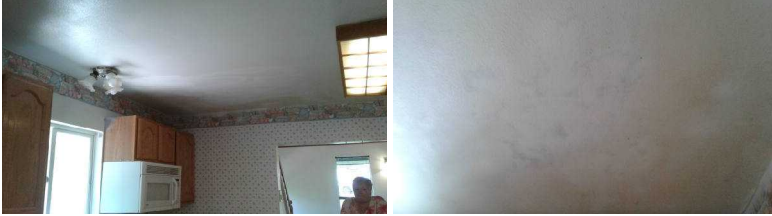
14. Ceiling: Paint - Light above window would not work or bulbs out.  
potential mold on ceiling and water damage.

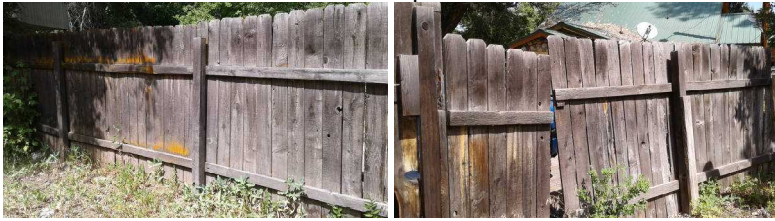
1. Fences: Wood, Picket - Needs replacement, Wood rot or pest damage, A qualified contractor is recommended to evaluate and estimate repairs

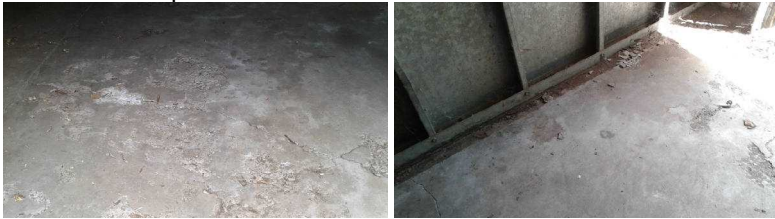
6. Detached, Side, Rear Garage Floor/Foundation: Poured concrete, Poured slab - Minor floor cracks noted-seal cracks, Spalled foundation corners

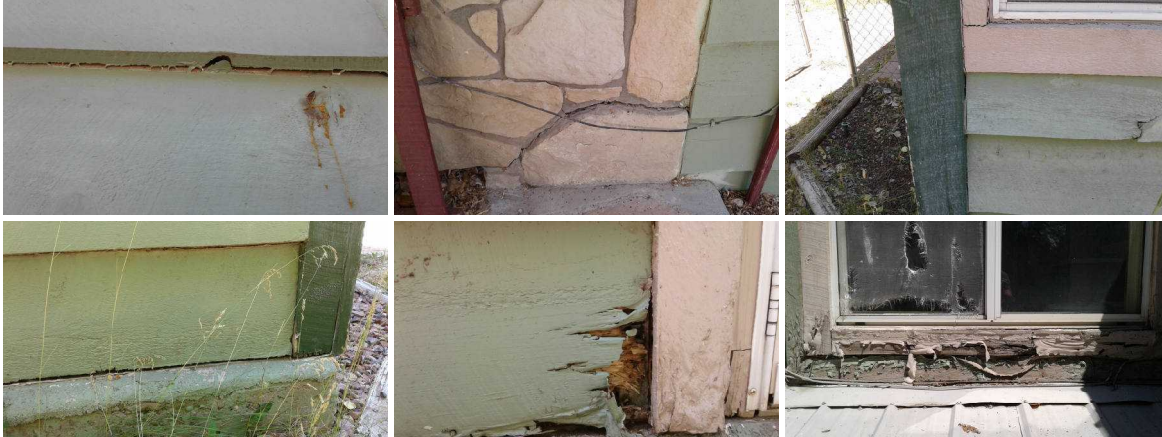
1. North, East, South, West, 1st Floor Exterior Surface Type: Wood - Paint peeling, Rot noted, Stress cracks

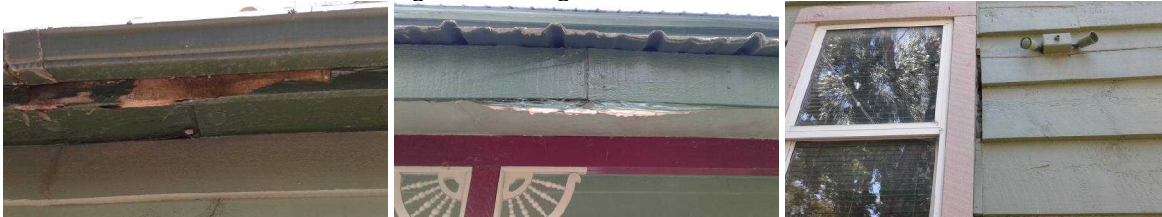
2. Trim: Wood - Wood rot, Damaged, Missing, Loose

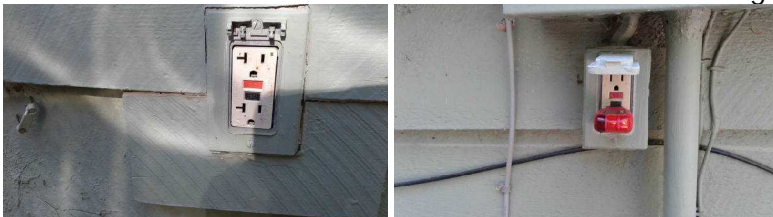
5. Exterior Electric Outlets: 110 VAC GFCI - Loose or missing moisture cover. GFCI test fail by electrical box.

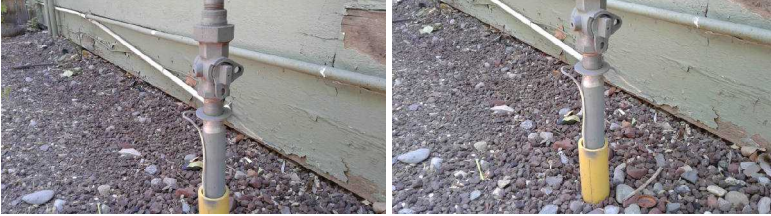
6. Main Gas Valve: Located at gas meter - Ground wire not attached. A licensed plumber is recommended to evaluate and estimate repairs.

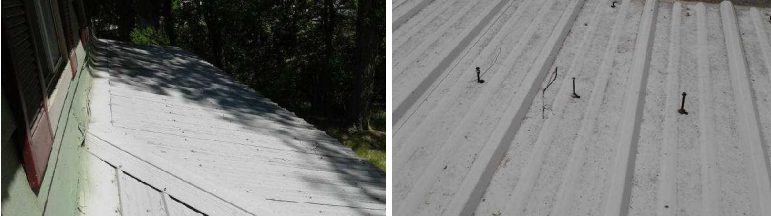
7. Main Roof Surface Material: Tin - Metal fastened improperly, A qualified roofing contractor is recommended to evaluate and estimate repairs

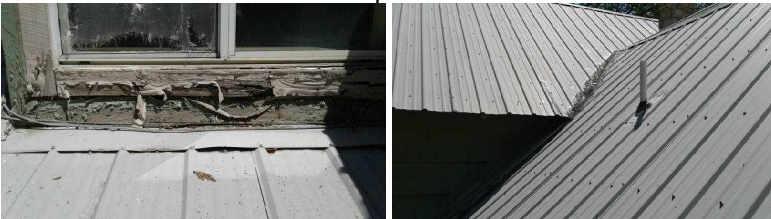
8. Flashing: Aluminum, Galvanized - Prone to possible leaks, A qualified roofing contractor is recommended to evaluate and estimate repairs

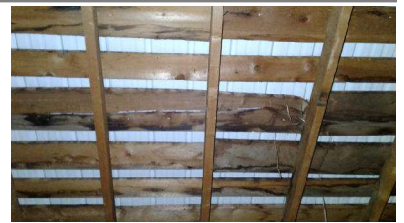
12. Main Attic Roof Framing: Rafter - Water damage present, Water stains present, A structural engineer is recommended to evaluate and estimate repairs

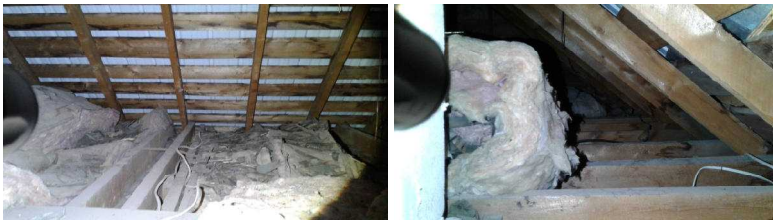
13. Main Attic Insulation: Batts, Fiberglass - Insulation has been damaged by moisture. Insufficient insulation present, No insulation present, Recommend additional insulation be installed, A qualified contractor is recommended to evaluate and estimate repairs, Insulation batts have fallen out of position-properly reinstall.

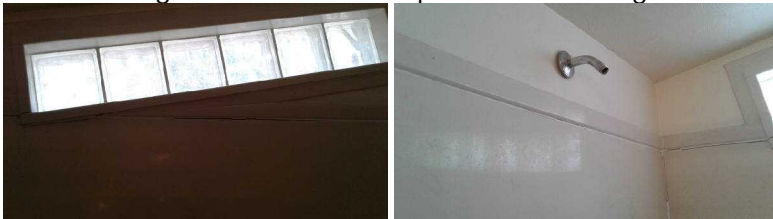
20. 1st floor main "jumbo" Bathroom Shower/Surround: Porcelain pan and ceramic tile surround, Porcelain pan and fiberglass surround - Replace old caulking at the shower pan, Loose grout. missing shower head.

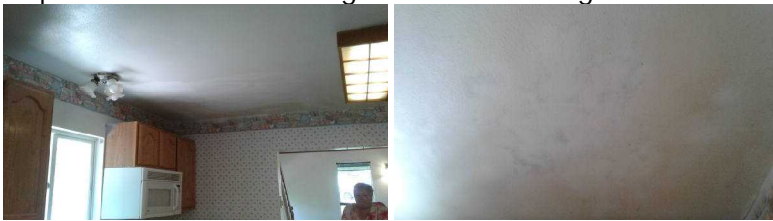
24. 1st Floor Kitchen Ceiling: Paint - Light above window would not work or bulbs out. potential mold on ceiling and water damage.
